Attachment T - Chantilly HQ Maintenance Yard

VDOT MS4 (General Permit No. VAR04)
Chantilly Area Headquarters
VDOT District No. 9

Facility Name: Chantilly Area Headquarters

Date of Visit: October 25, 2012

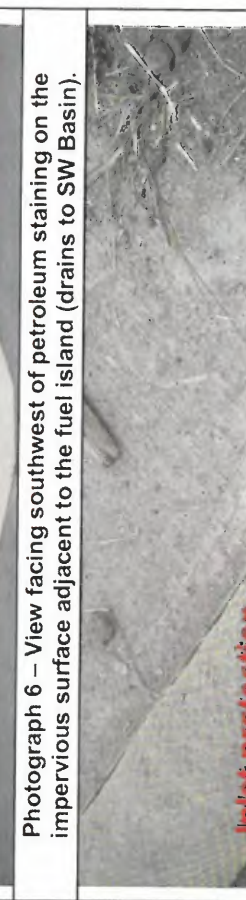
7. Heavy rust/petroleum/salt staining was observed underneath multiple pieces of salt dispensing equipment on the northern side of the Facility (see Photographs 3 and 4). This area of the Facility drains to the on-site salt pond.
8. Visible petroleum staining was observed on the impervious surface at the fuel island in the south-central portion of the Facility (see Photographs 5 and 6). This area of the Facility drains to the stormwater basin.
9. Storm drain inlet protection on the west side of the Facility did not protect the entire storm drain inlet (see Photographs 7 and 8). An approximate six inch section of the storm drain inlet was observed exposed. The inlet protection appeared to be newly installed to the EPA Inspection Team. This area of the facility drains to the on-site salt pond.

Site Photographs	VDOT MS4 (General Permit No. VAR04) Chantilly Area Headquarters VDOT District No. 9	Photograph Date: 10/25/2012
 	 	<p>Photograph 1 – View facing east of petroleum staining on the impervious surface adjacent to the Facility maintenance shop (drains to SW Basin).</p> <p>Photograph 2 – View facing southeast of petroleum staining on the impervious surface adjacent to the Facility wash bay (drains to SW Basin).</p>
 	 	<p>Photograph 3 – Close-up view of petroleum, rust, and salt staining on the impervious surface on the north-central side of the Facility (salt pond).</p> <p>Photograph 4 – View facing northeast of petroleum, rust, and salt staining on the impervious surface on the north-central side of the Facility.</p>
